# Memorandum

Attention: Roger Burra  
Company: NZ Transport Agency  
Date: 12 April 2013  
From: Stephen Fuller  
Message Ref: **SH 1 Paekakariki - Fly by Wire valley investigations**  
Project No: W13022

## Introduction

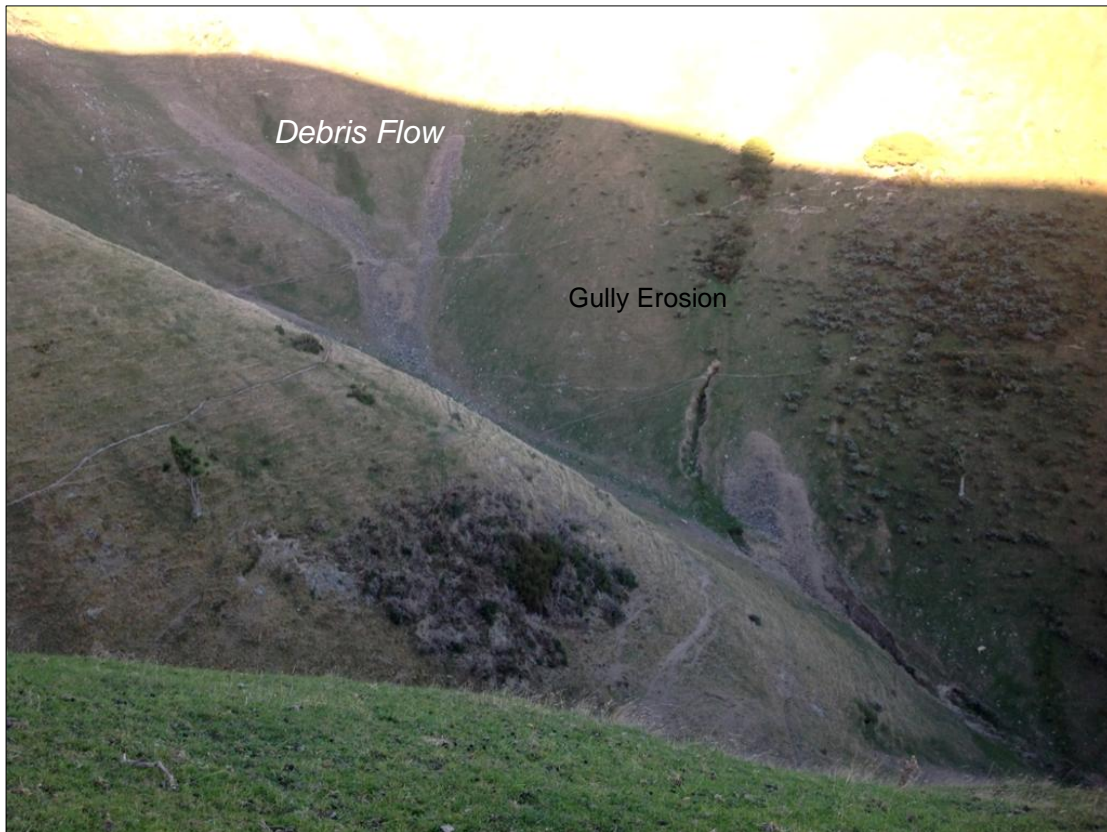
- Despite large visible areas of debris flows on steep slopes, these appeared to be ancient and relatively stable. Overall, there was far less mass slope failure than expected (Photos 1 & 2).
- Almost all contributing erosion was gully erosion. This was highlighted in the two reports provided (Duffill Watts & Tse Ltd 2003, and Williams 2008). However, Williams noted in his report that there had been considerable healing. Our observations were that almost all of the gullies that contained major erosion scars had been recently active and there was virtually no revegetation of these gullies. There have been several significant rainfall

Photo 1: Debris flows on steep slopes. These appeared to be ancient and relatively stable.

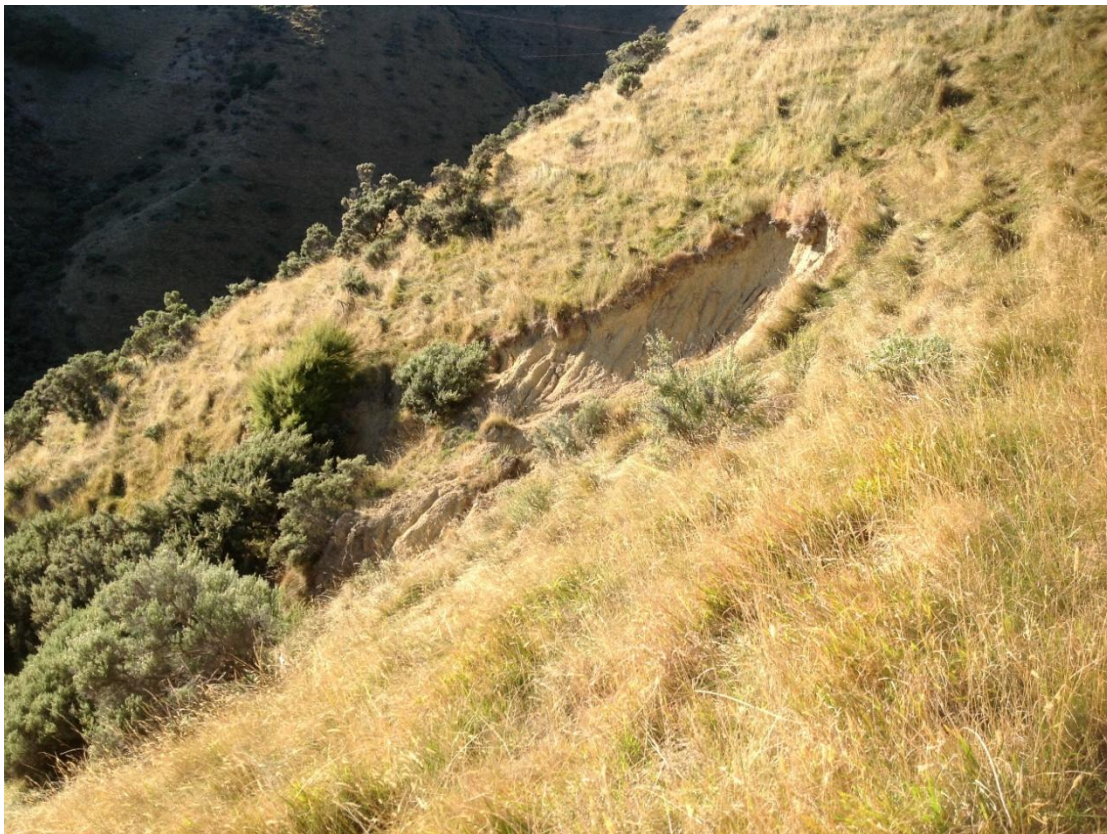
Photo 2: Small midslope failures like this are relatively uncommon.

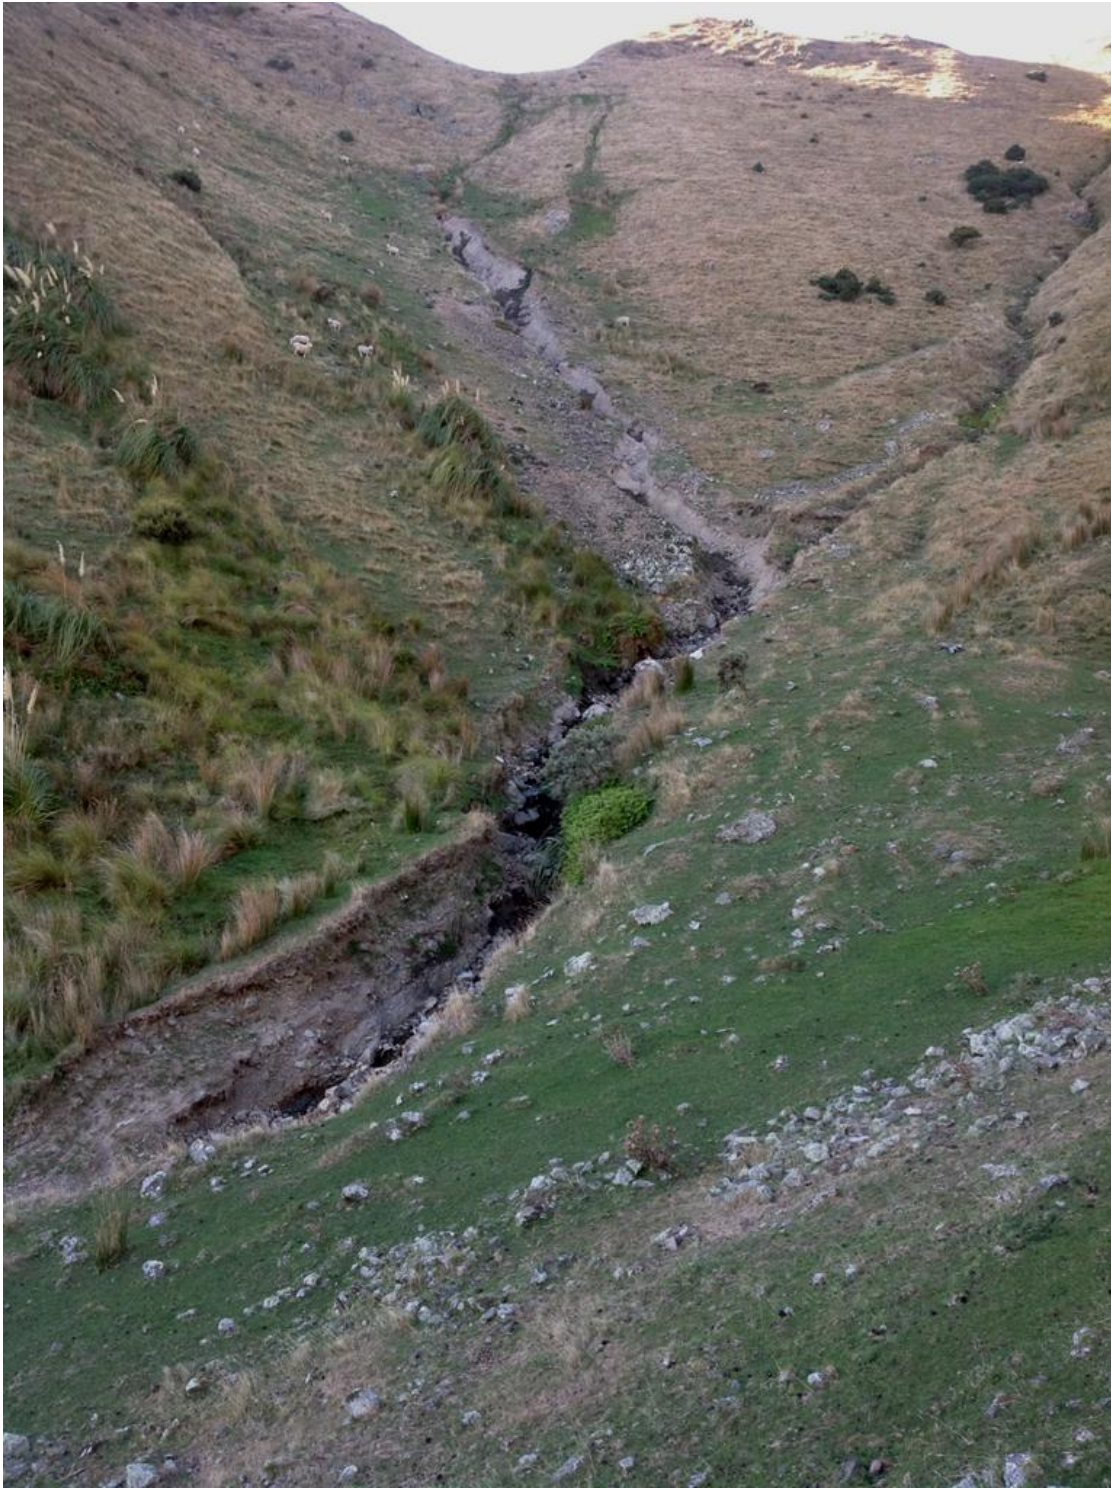
events in recent months which may have caused this movement (Photos 3, 4, 9, 11, 16, and 17).

Photo 3: Active and gully erosion in Fly-by-wire gully.

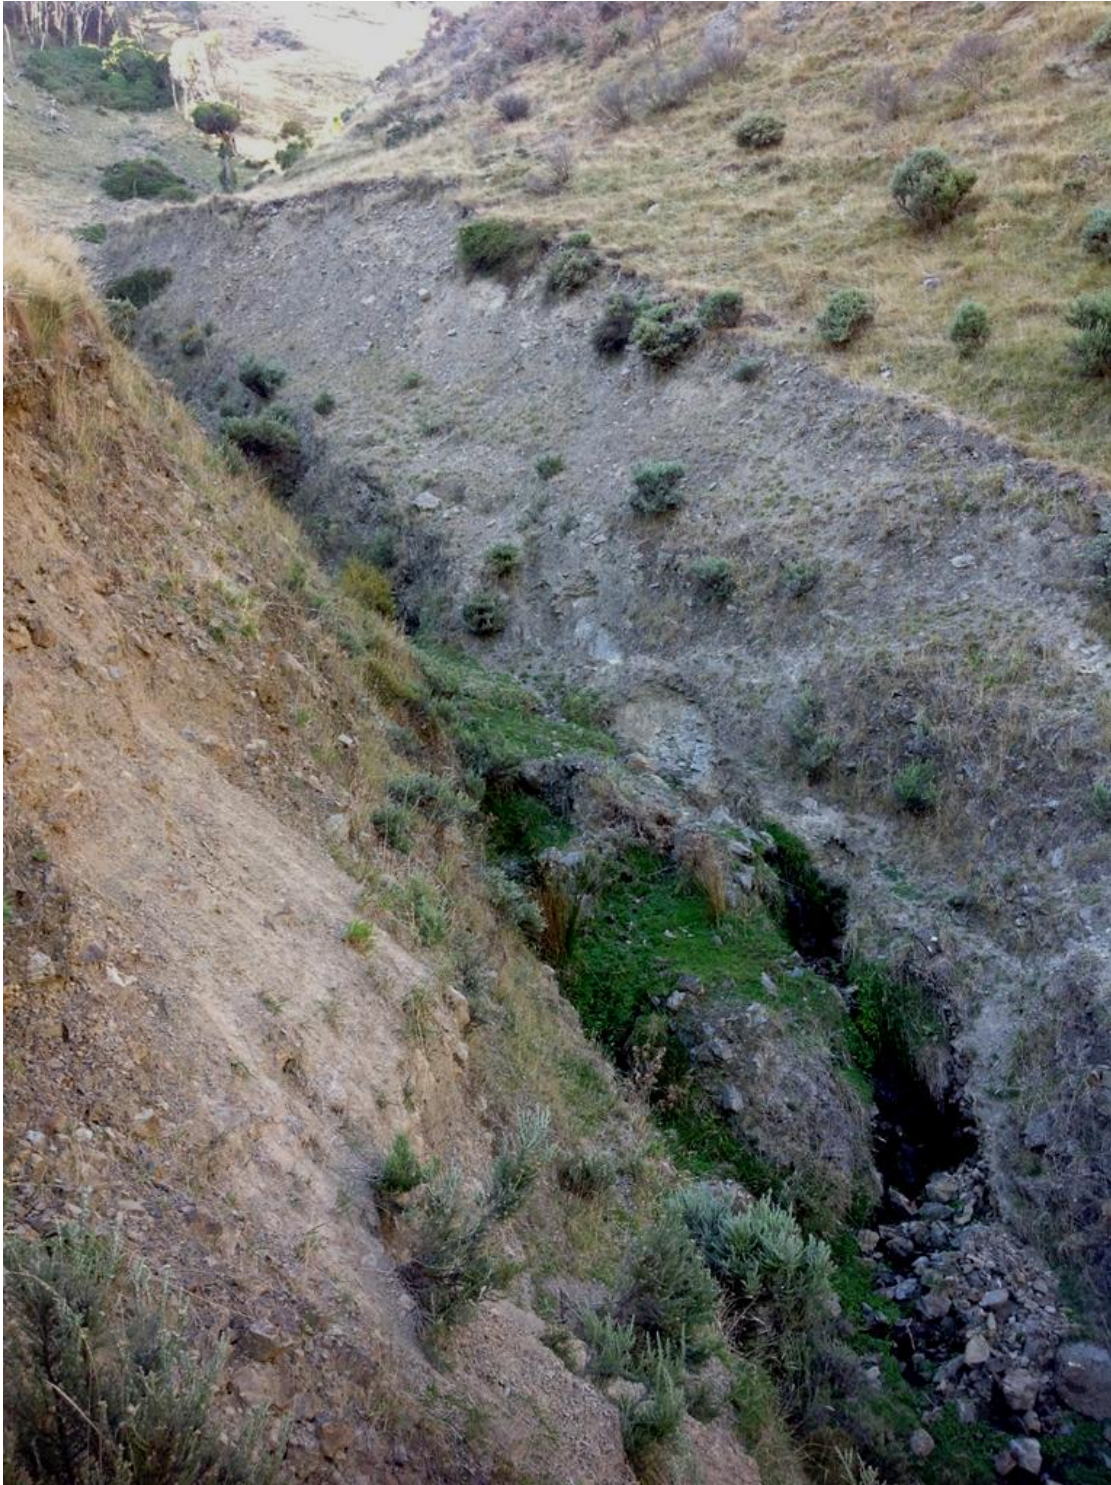
Photo 4: Stabilising gully erosion in Hill Road Gully.

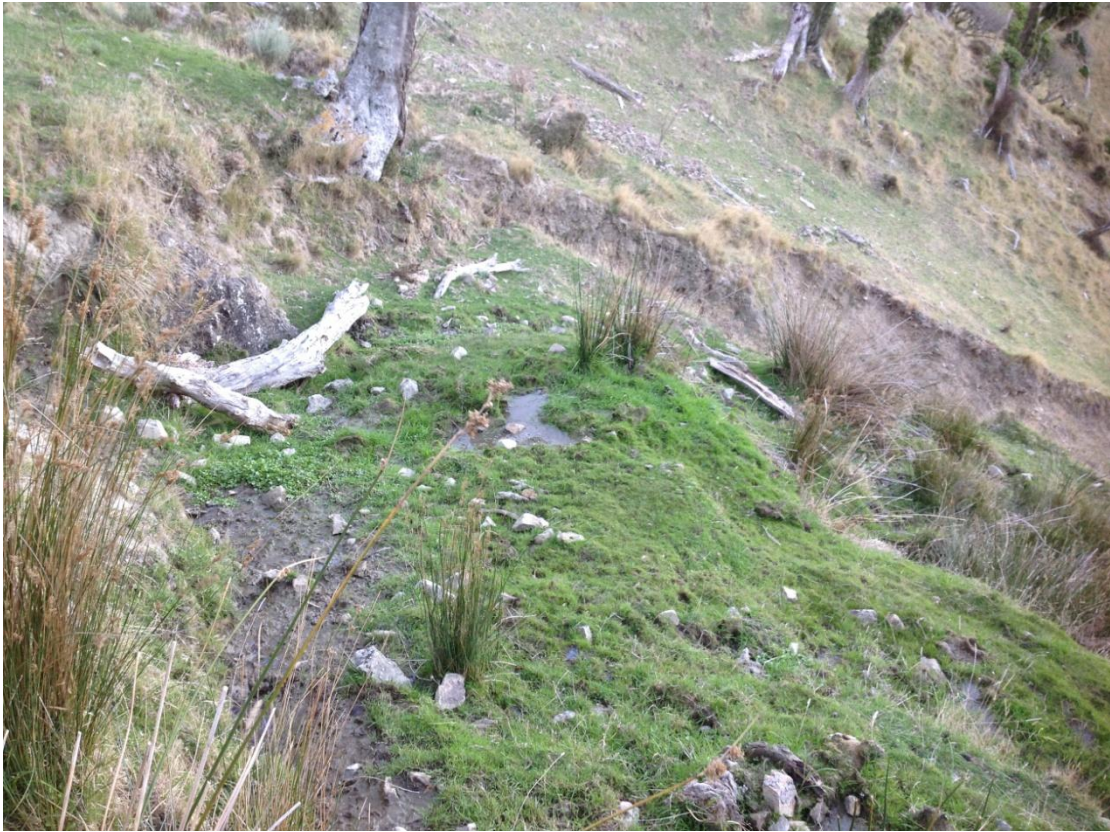
- Almost all gully erosion had as its upper slope terminus an active spring (Photos 5 and 6). We assume that the contribution of the spring was that it kept the gullies moist, even during summer, and so ensured persistent weathering and weakening of the underlying greywacke throughout the year.

Photo 5: Freshwater spring and rushland at the top of a major zone of gully erosion.

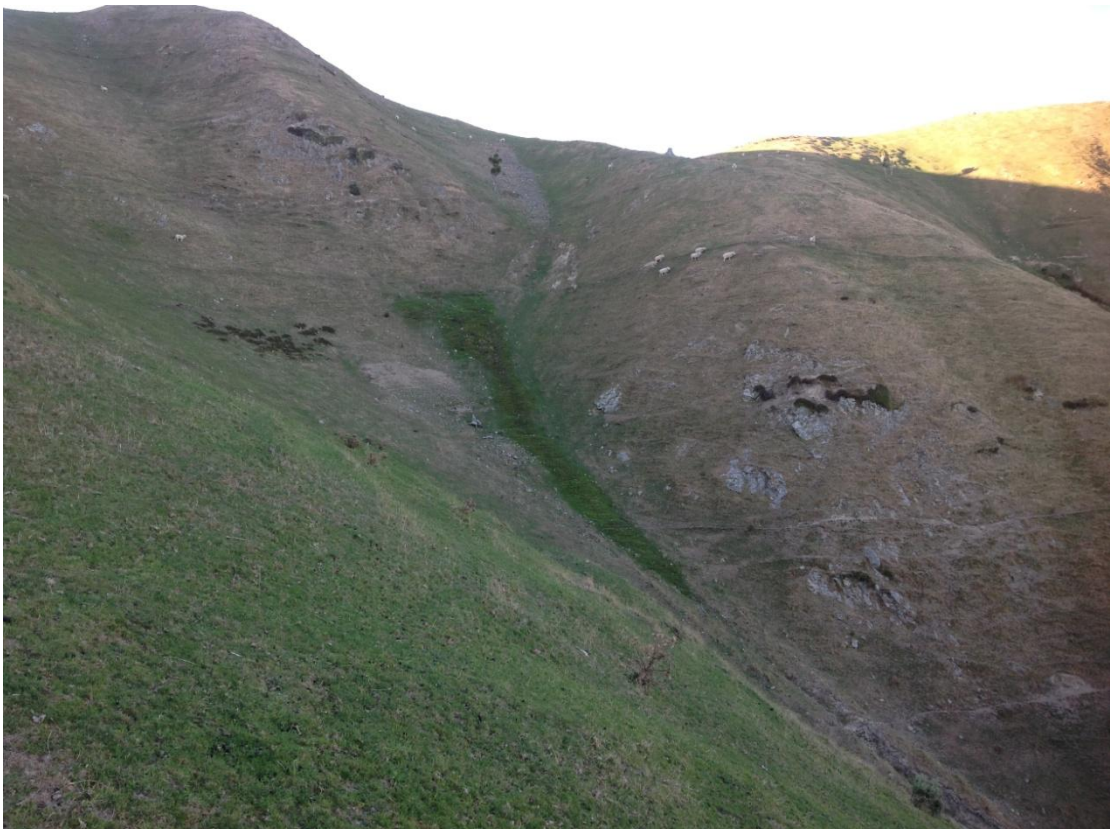
- The report of Williams suggested that erosion commenced in the head of each gully. However, from a number of gullies that we climbed our read of the process was that the erosion did not commence at the head of the gully but rather in the much steeper lower slope sections. Once the initial failure had occurred erosion then 'ate' its way upslope as the stream attempted to find grade, eventually reaching the headwater spring (Photos 6, to 9).

Photo 6: Freshwater spring in a gully head. Gully erosion creeping upslope toward the spring from bottom right.

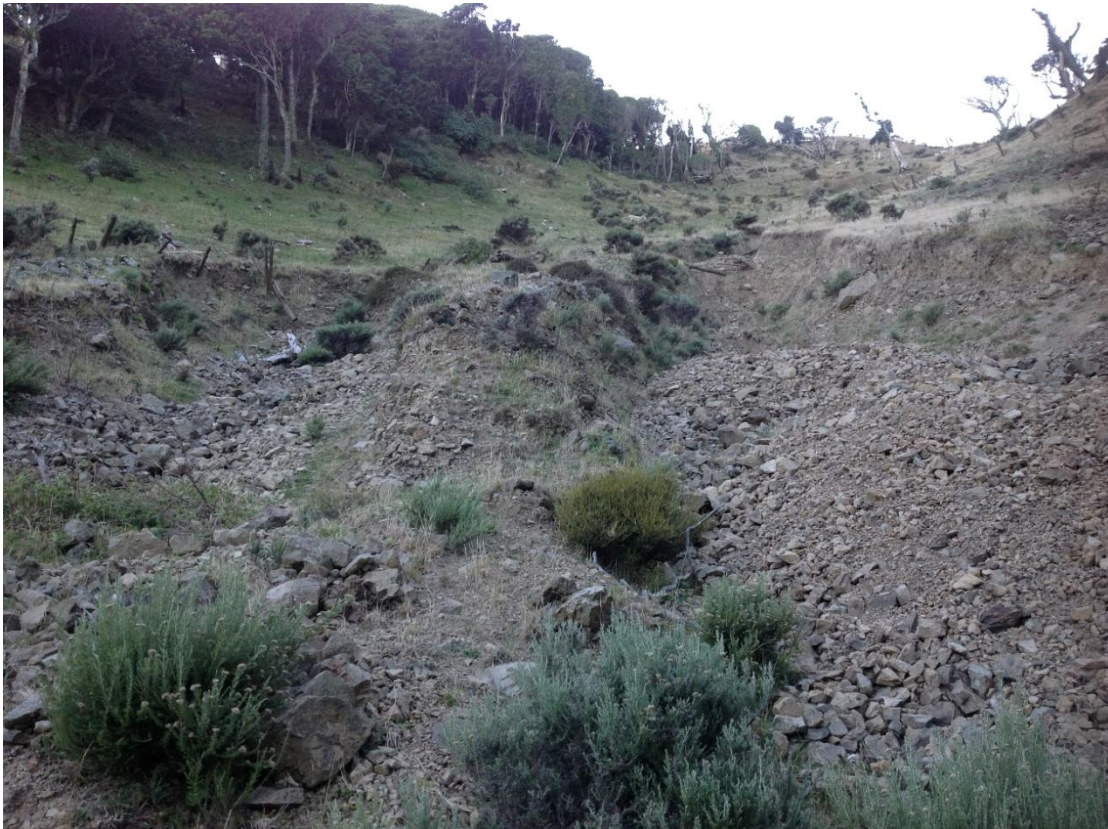
Photo 7: One of the larger erosion scars in Hill Road Gully. There has been some stabilisation by native shrubs but areas of continuing failure are also present.

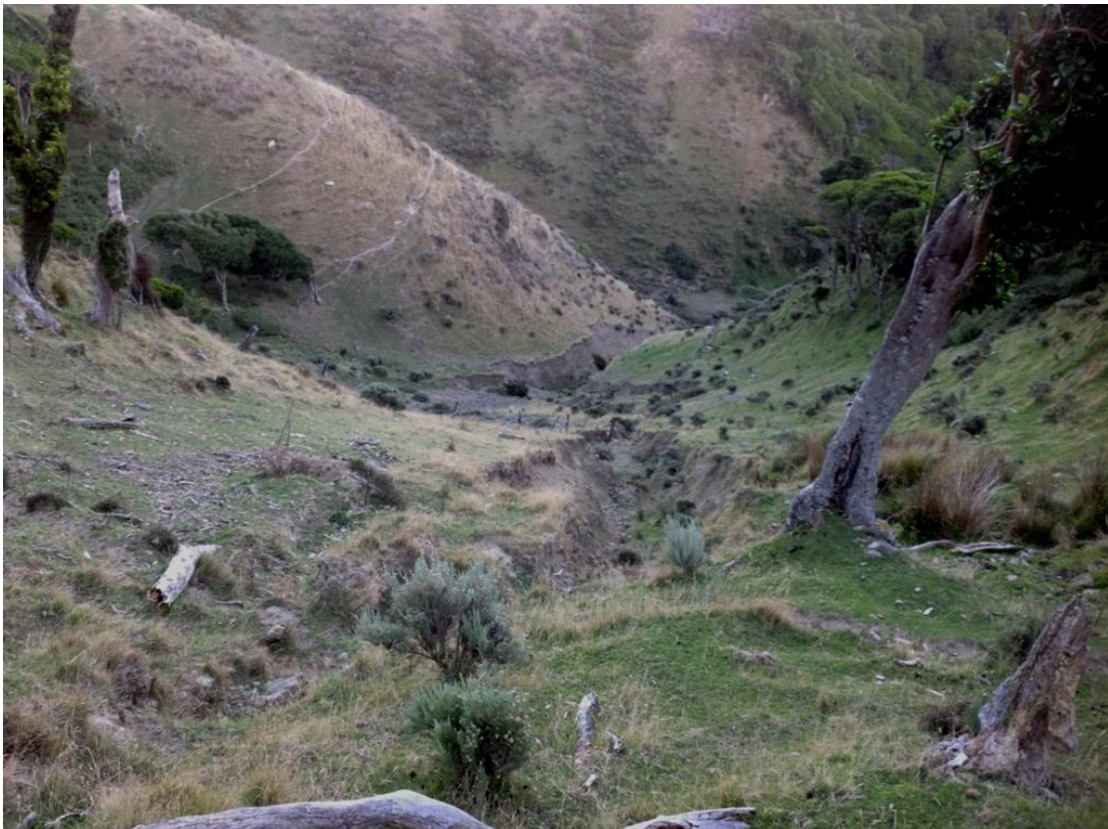
Photo 8: The upper extent of gully erosion shown in the previous photo.

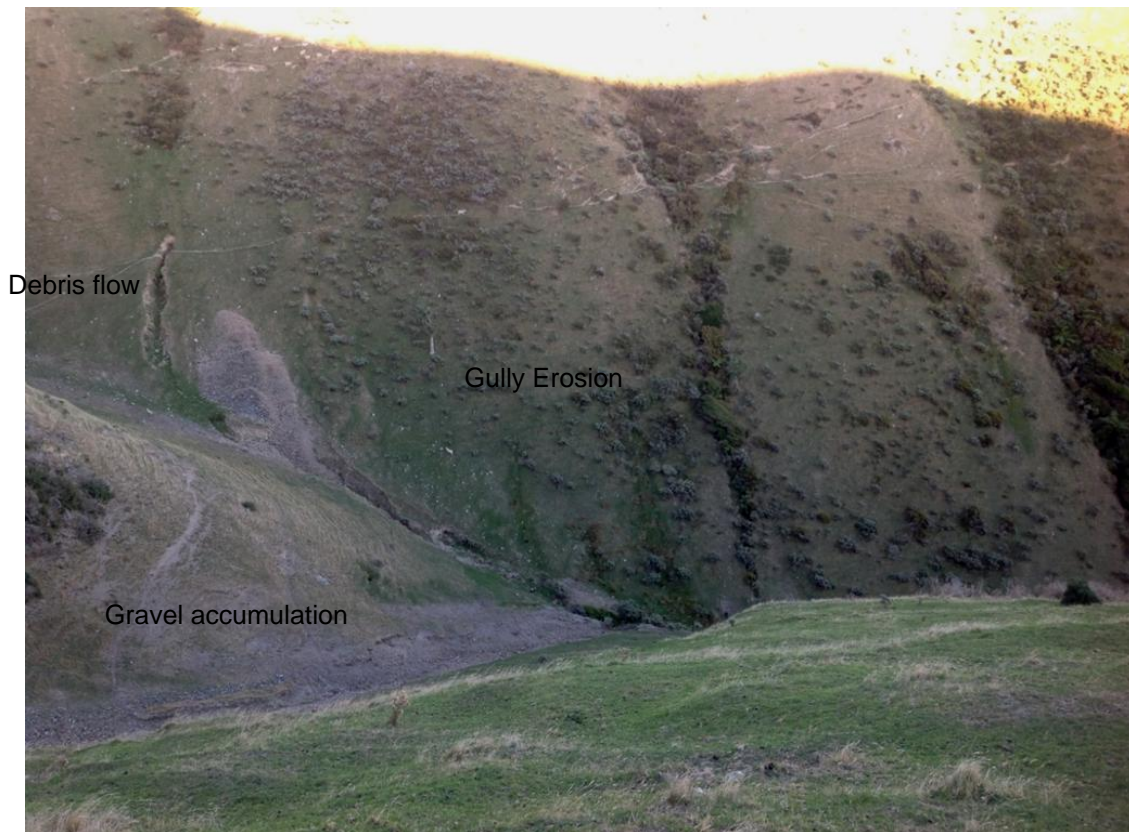
- There was far less obvious erosion of the main stream channels than expected and the lower sections of the Fly-by-wire Gully were relatively free of debris (Photo 19). There remains, however, a significant accumulation of material in the upper sections of these streams and the discharge points of the larger eroded side gullies (Photos 9 to 12).

Photo 9: Significant accumulation of mobile material in the upper sections of Hill Road Gully with continuing gully erosion occurring.

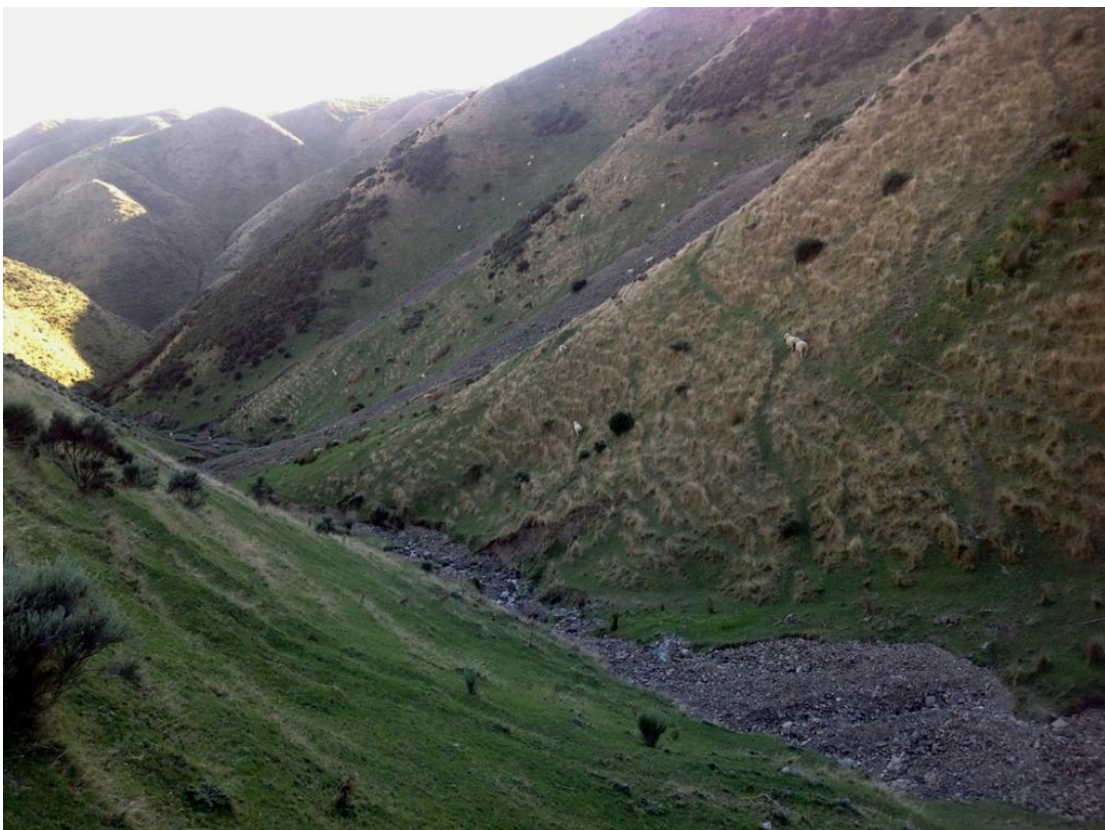
Photo 10: Significant accumulation of mobile material in the upper sections of Fly-by-wire Gully.

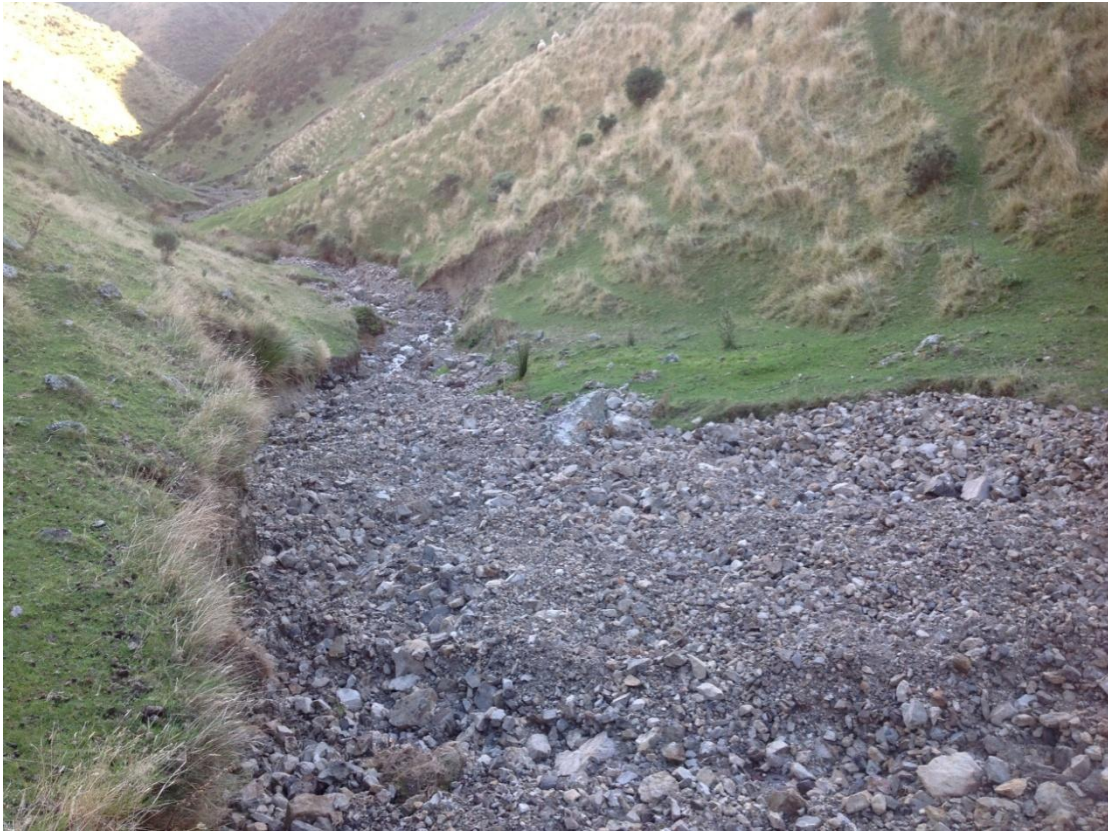
Photo 11: Accumulation of mobile material in the upper sections of Fly-by-wire Gully.

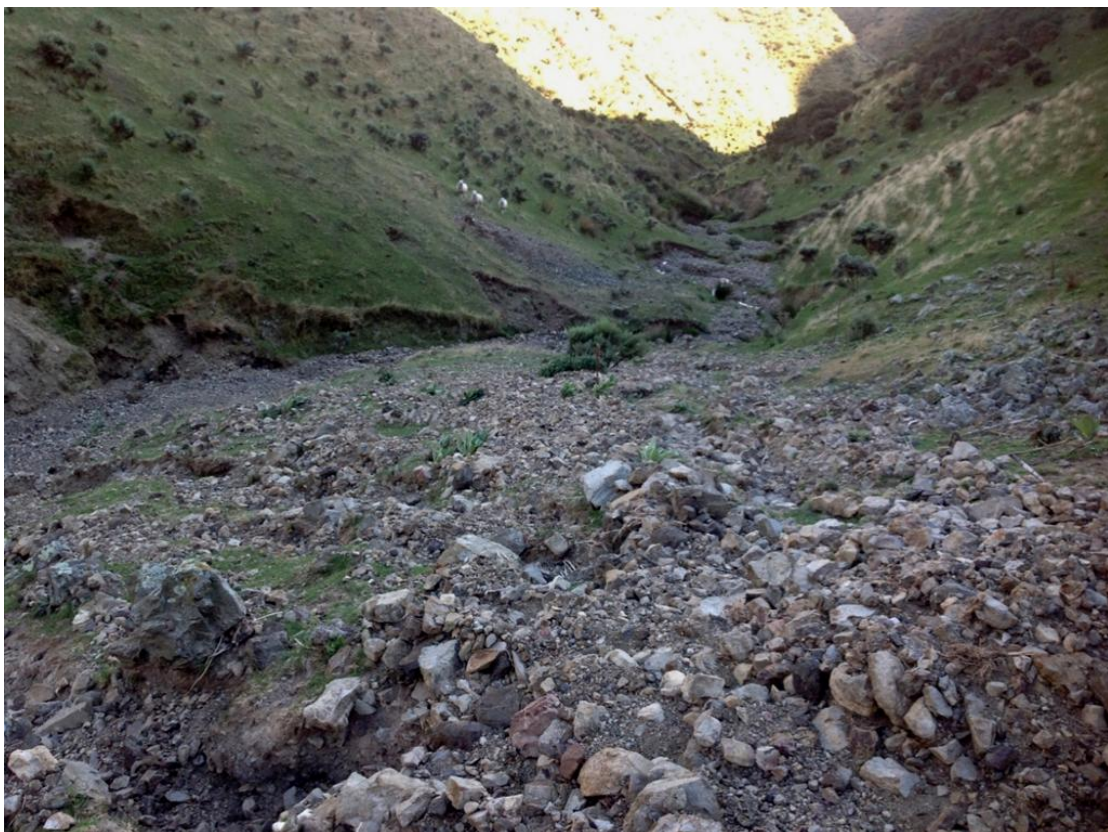
Photo 12: Gravel fan at the bottom of an eroding gully in the upper sections of Fly-by-wire Gully.

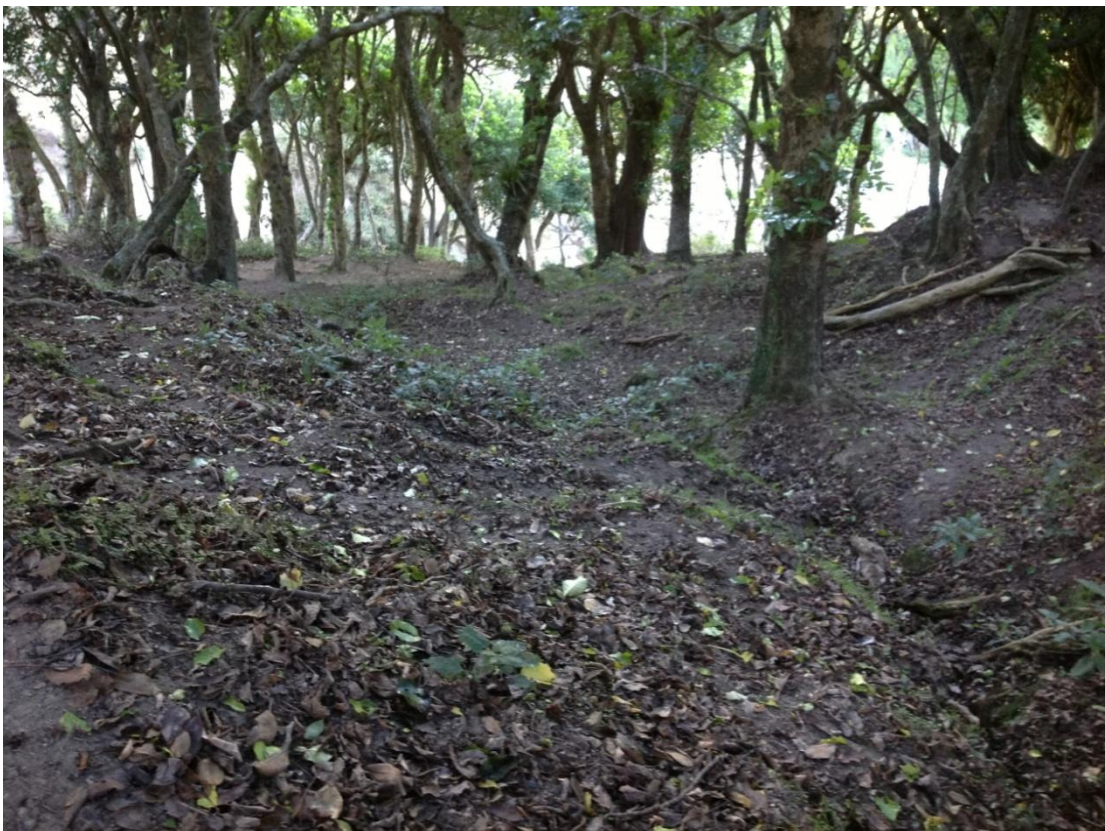
- The areas of native forest that have not been cleared are dominated by kohekohe, mahoe and karaka, and use of these stands for stock shelter mean there is no understorey or ground cover. Generally native forest stabilised the slopes (Photos 13 and 14), however, where the native forest had an open canopy due to stocking and die back, the erosion was able to eat upslope into the forest (Photos 15 and 16).

Photo 13: Some minor erosion of a gully in native forest in Hill Road Gully.

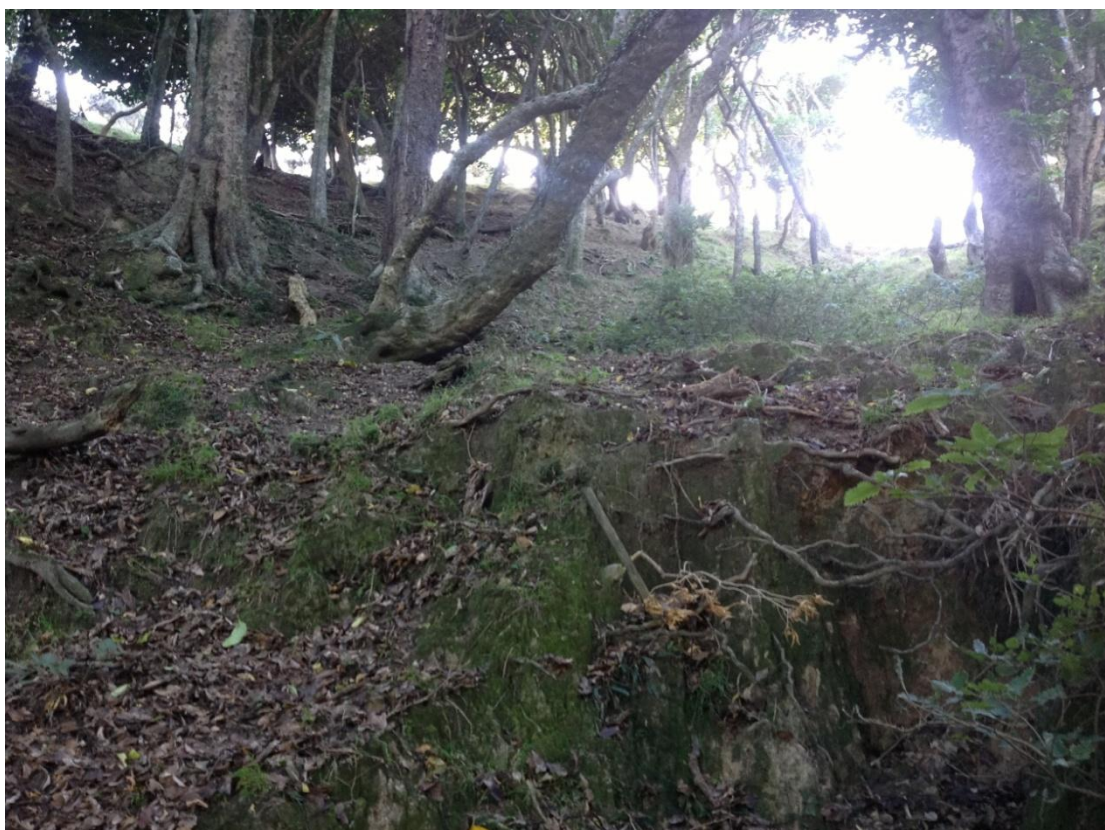
Photo 14: Looking upslope as for above photo

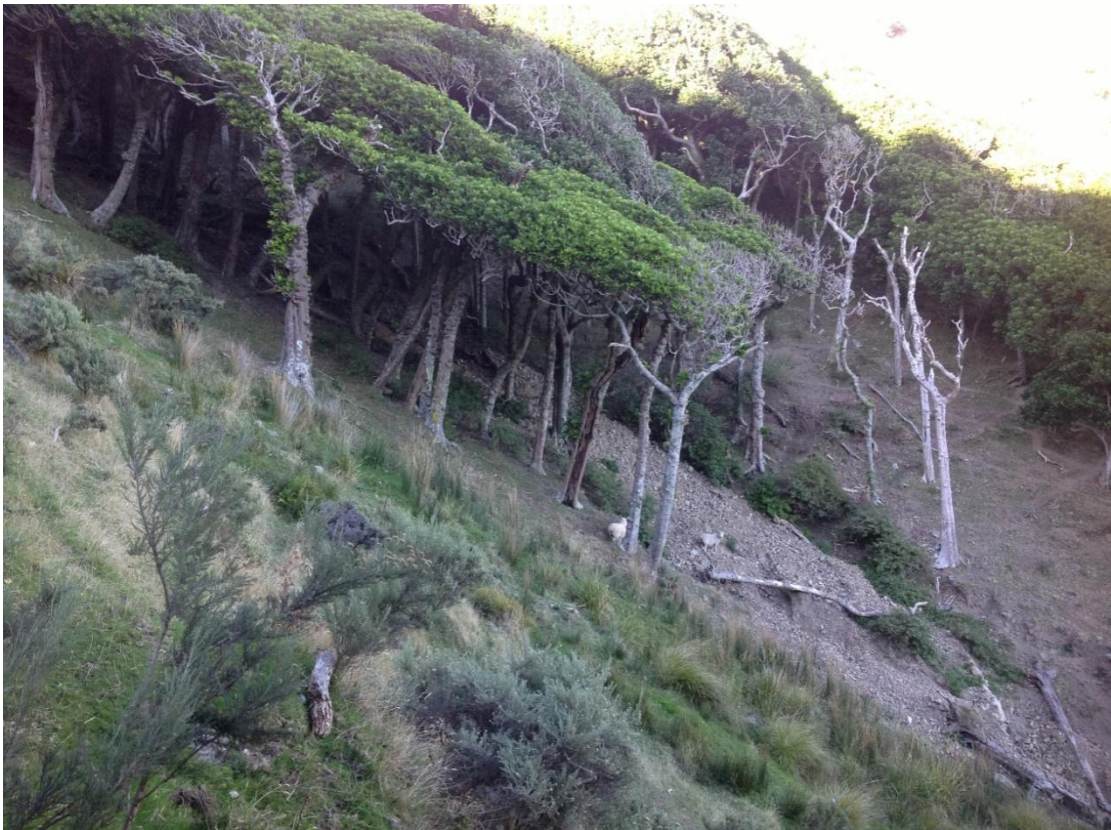
Photo 15: Unstable gully erosion that has extended upslope into heavily grazed native forest.

- 4. Fence Native Forest.** The few fragments of native forests are currently used as shelter for stock. In areas intense grazing of the understorey has resulted in die back and allowed erosion into and through the stands. If under Option 1 and 2 above, the valley were to continue to be farmed, fencing of these forests would allow them to thicken, margins and understorey to form, and would ensure ongoing erosion control. These forests will also provide a seed source for any native regeneration that is allowed or encouraged. The loss of this bush as stock shelter would be compensated by the planting of poplars. The area we recommend be fenced and retired under this option is shown on the attached Map, and is in the order of 12 ha.

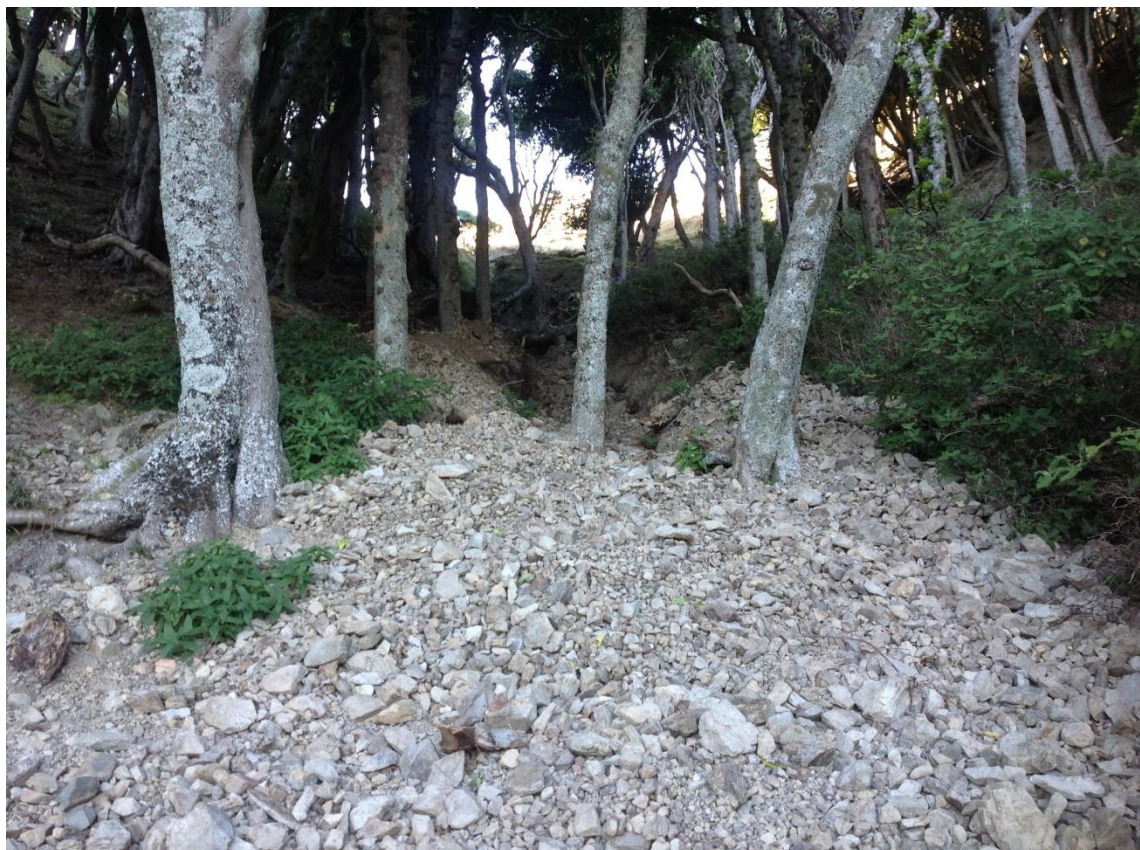
Photo 16: Looking upslope into forest in previous photo.

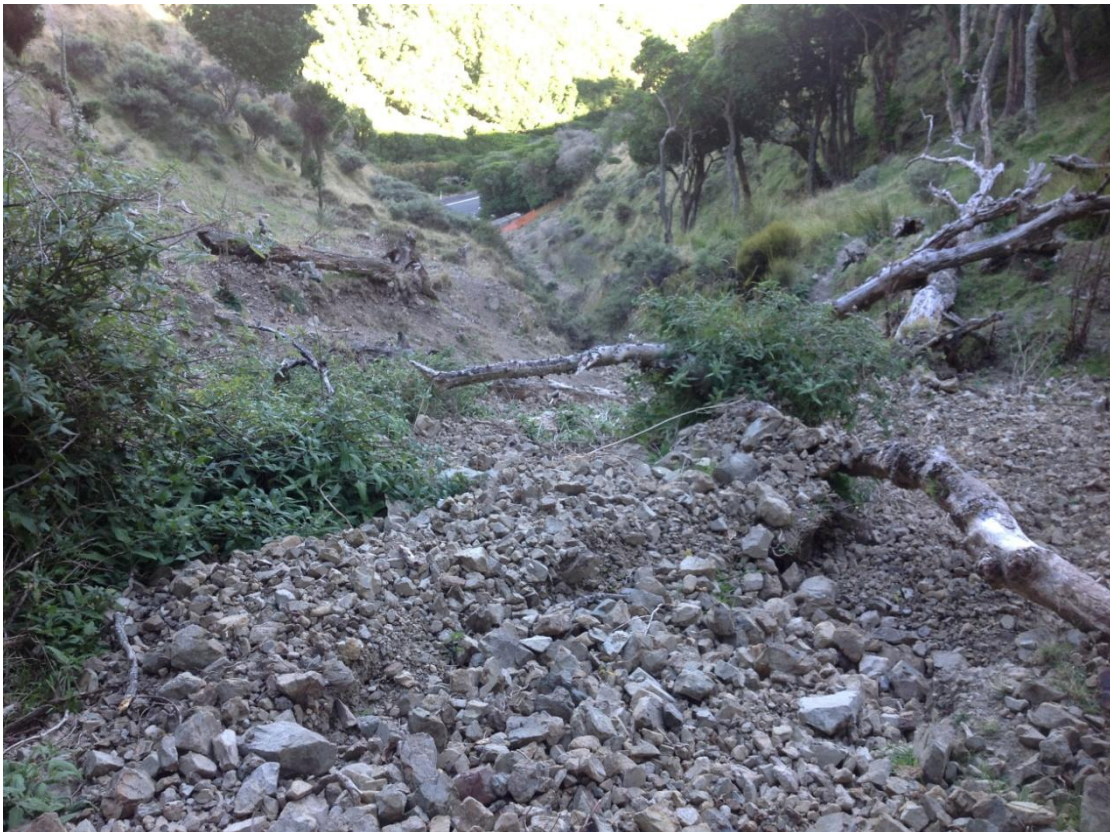
Photo 17: Looking downslope from previous photo.

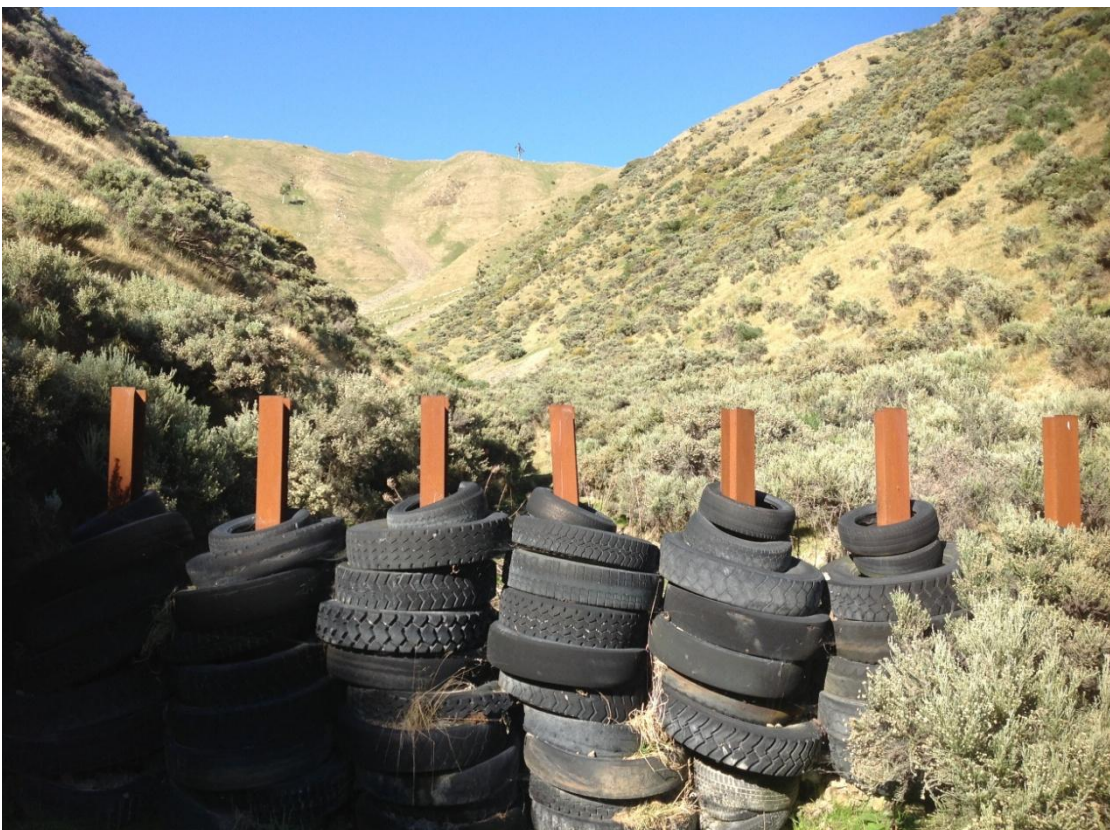
Photo 18: Debris collector at the bottom of Hill Road Gully

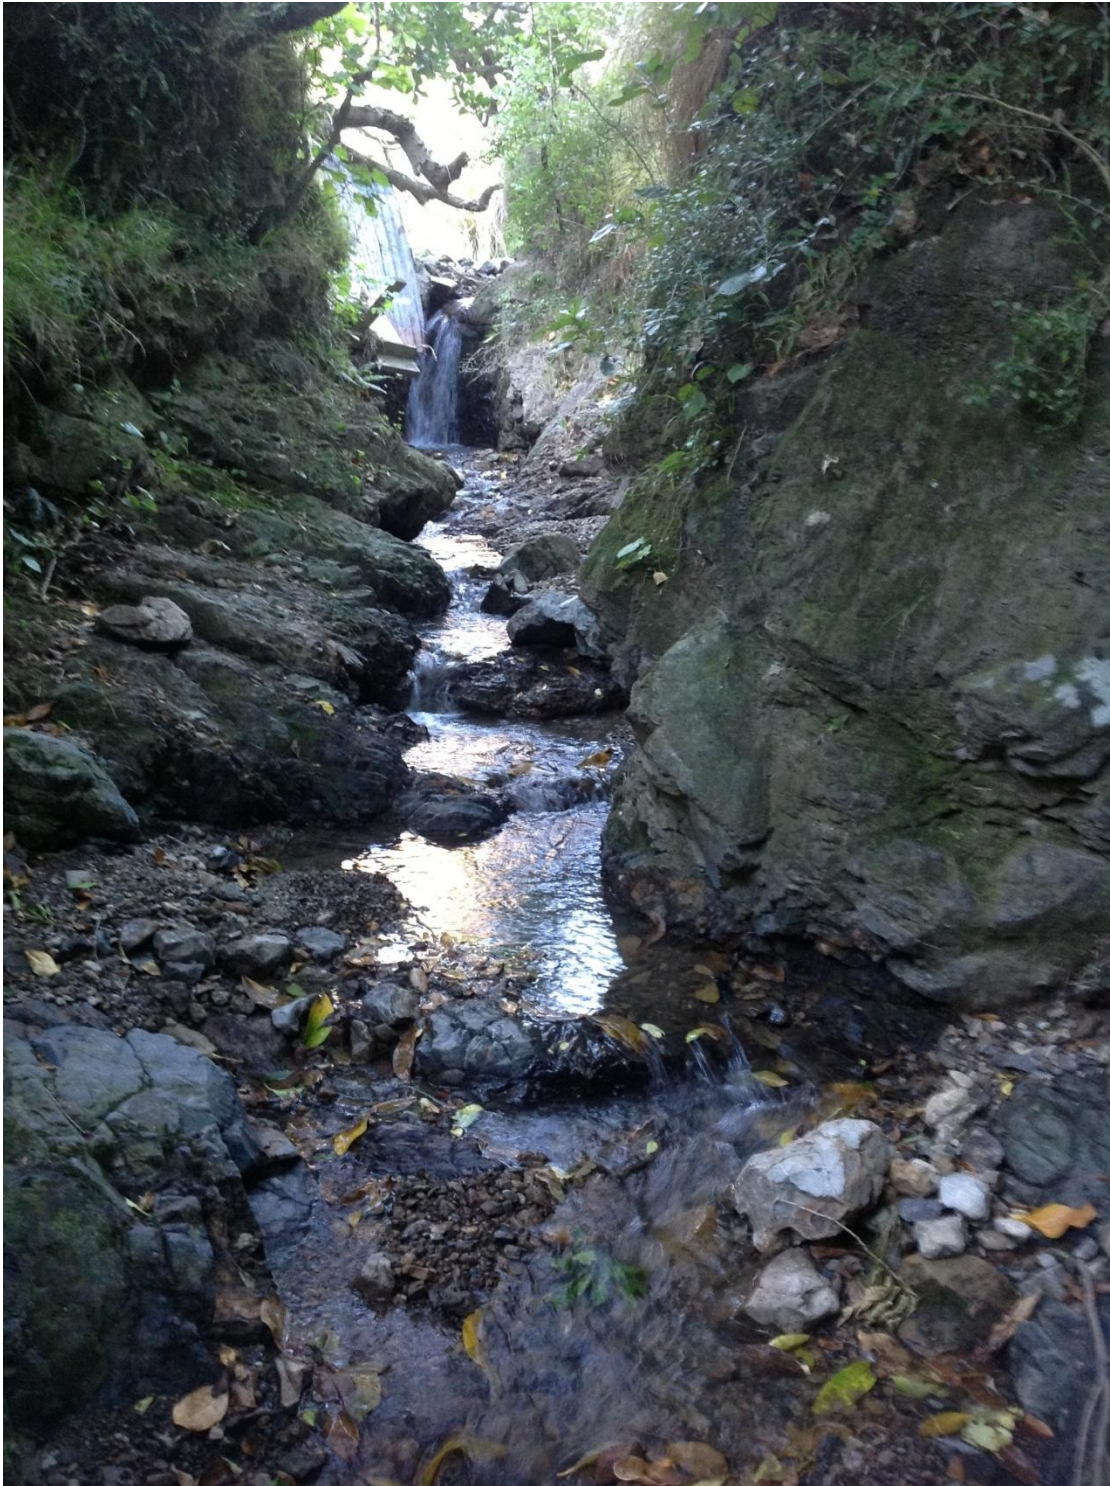
Photo 19: The forested gorge in Fly-By-Wire Gully.
